**Re: Performance Verification Plan for Certificate of Compliance at  
Former Squamish Pulp Mill, Woodfibre, BC (Uplands Portion)  
MOE Site ID: #9930  
Keystone Environmental Project No. 11644**

Keystone Environmental Ltd. (Keystone Environmental) has prepared this Performance Verification Plan (PVP) in support of an application for a risk-based Certificate of Compliance (CofC) for the uplands portion of the property located at the Former Squamish Pulp and Paper Mill, Woodfibre, BC (herein referred to as the "Site"). The Site has MOE Site ID: 9930.

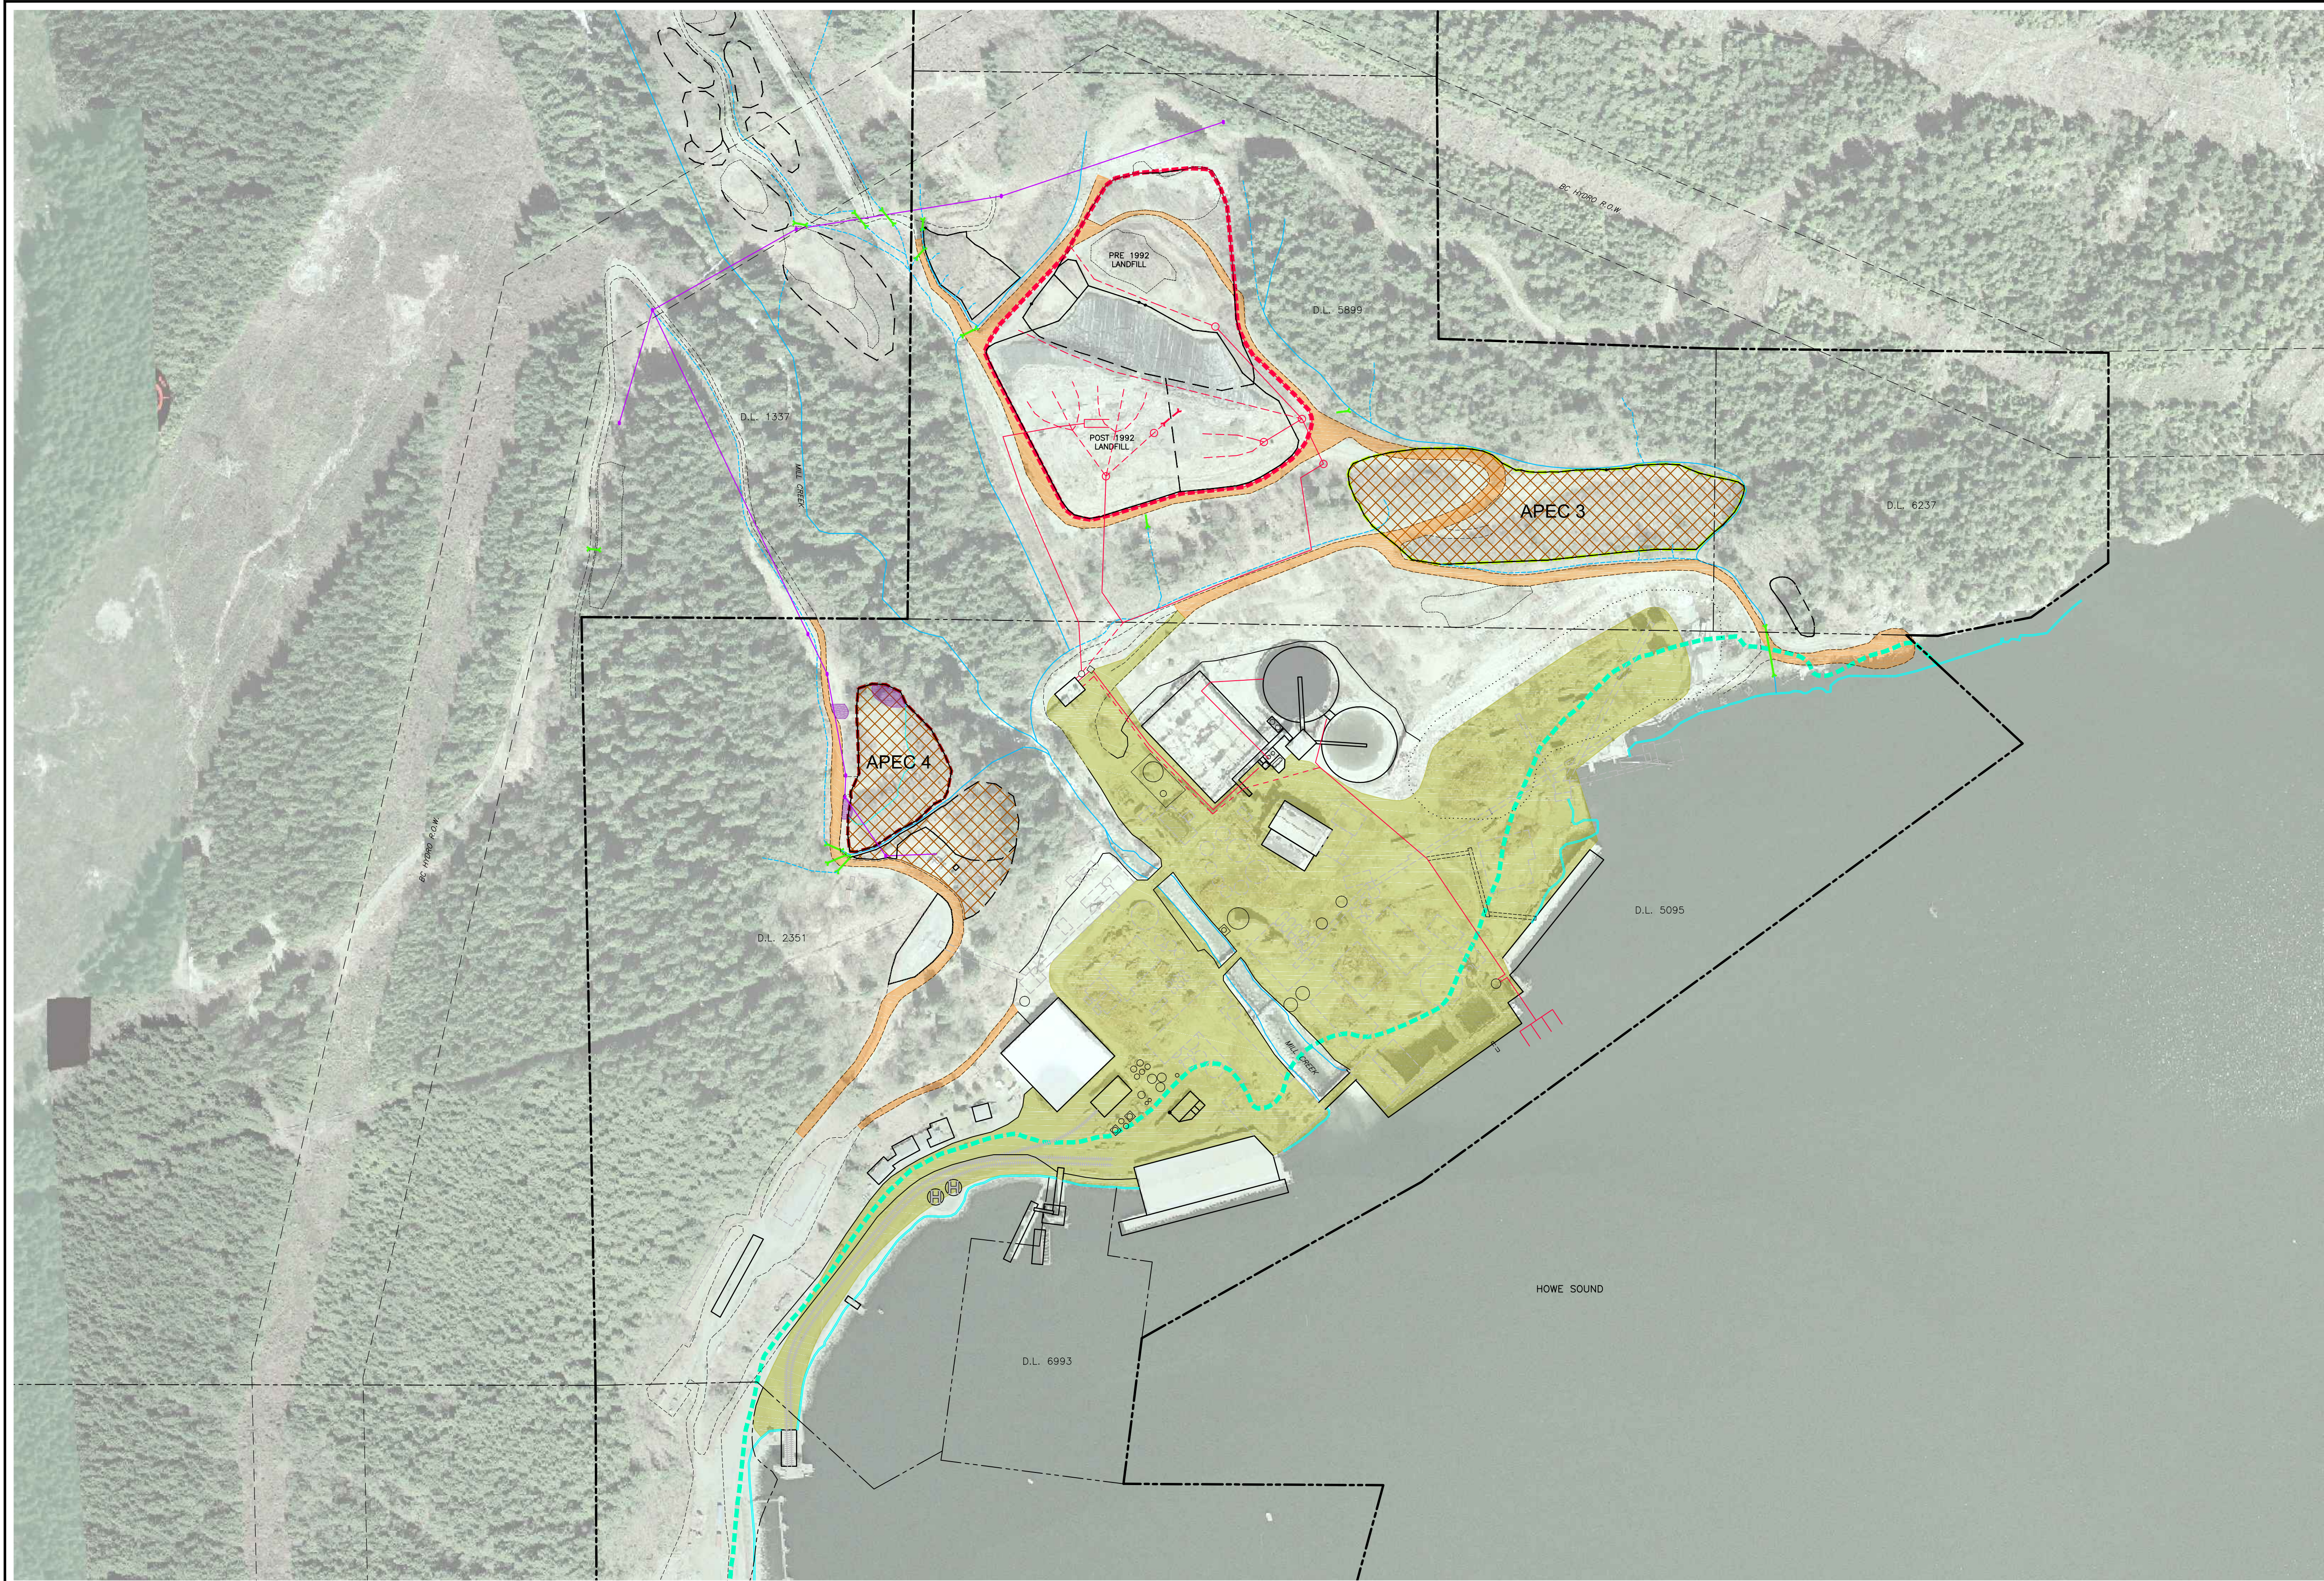
**Figure 1**  
Industrial Land Cover Composition

Figures 1 and 2 present these upland areas to be mitigated for risk.

- The overall grade of AEC 3 and AEC 4 (Figure 1) must not be reduced.
- The general public must not access the industrial areas of the Site.
- The groundwater must not be used as a source of drinking water.

- The overall grade of AEC 3 and AEC 4 (Figure 1) must not be reduced. Future development plans should be made available upon request by the Director.

- Engineered control(s) consisting of pavement/slab or suitable equivalent cover such as at least 1 m of clean fill with no deep rooting vegetation must remain in place at AECs 2 and 32. AECs 2 and 32 coincide with the area of the Site previously containing industrial operations.
- Engineered control(s) consisting of soil caps must remain in place at AEC 4.
- Intrinsic control(s) consisting of the overall grade must be largely maintained as is both currently and in the future at AEC 3 and AEC 4.
