Re: Performance Verification Plan for Certificate of Compliance 1000 Quayside Drive, New Westminster, BC Site ID: 16695 Project No. 11794

Keystone Environmental Ltd. (Keystone Environmental) has prepared this Performance Verification Plan (PVP) in support of an application for a risk-based Certificate of Compliance (CofC) for the off-site affected parcel listed as 1000 Quayside Drive, New Westminster, BC ("the Site").

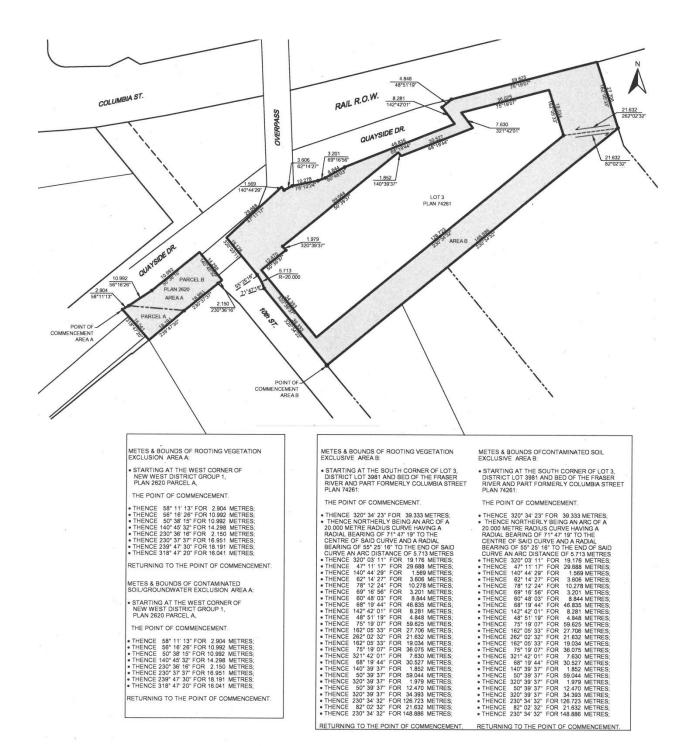
METES AND BOUNDS FIGURE

PROPERTY LINE
METES & BOUNDS

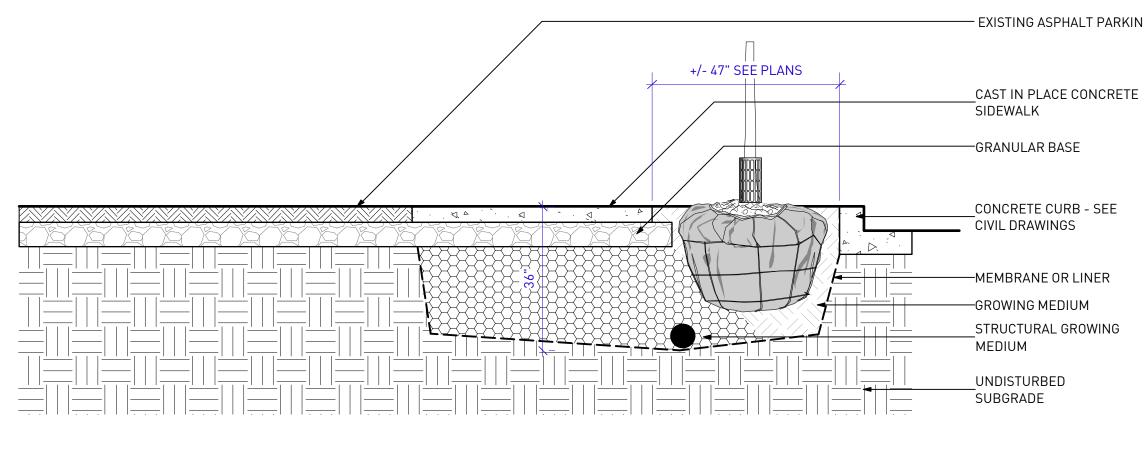
STRUCTURAL SOIL AND LINER DETAIL ALONG QUAYSIDE DRIVE - WEST OF BREEZEWAY 3 Scale: 1/2" = 1'-0"

STRUCTURAL GROWING MEDIUM UNDISTURBED SUBGRADE
