**Re:** Performance Verification Plan for Certificate of Compliance

18 Fell Avenue (Lot D), North Vancouver, BC

Project No. 14592

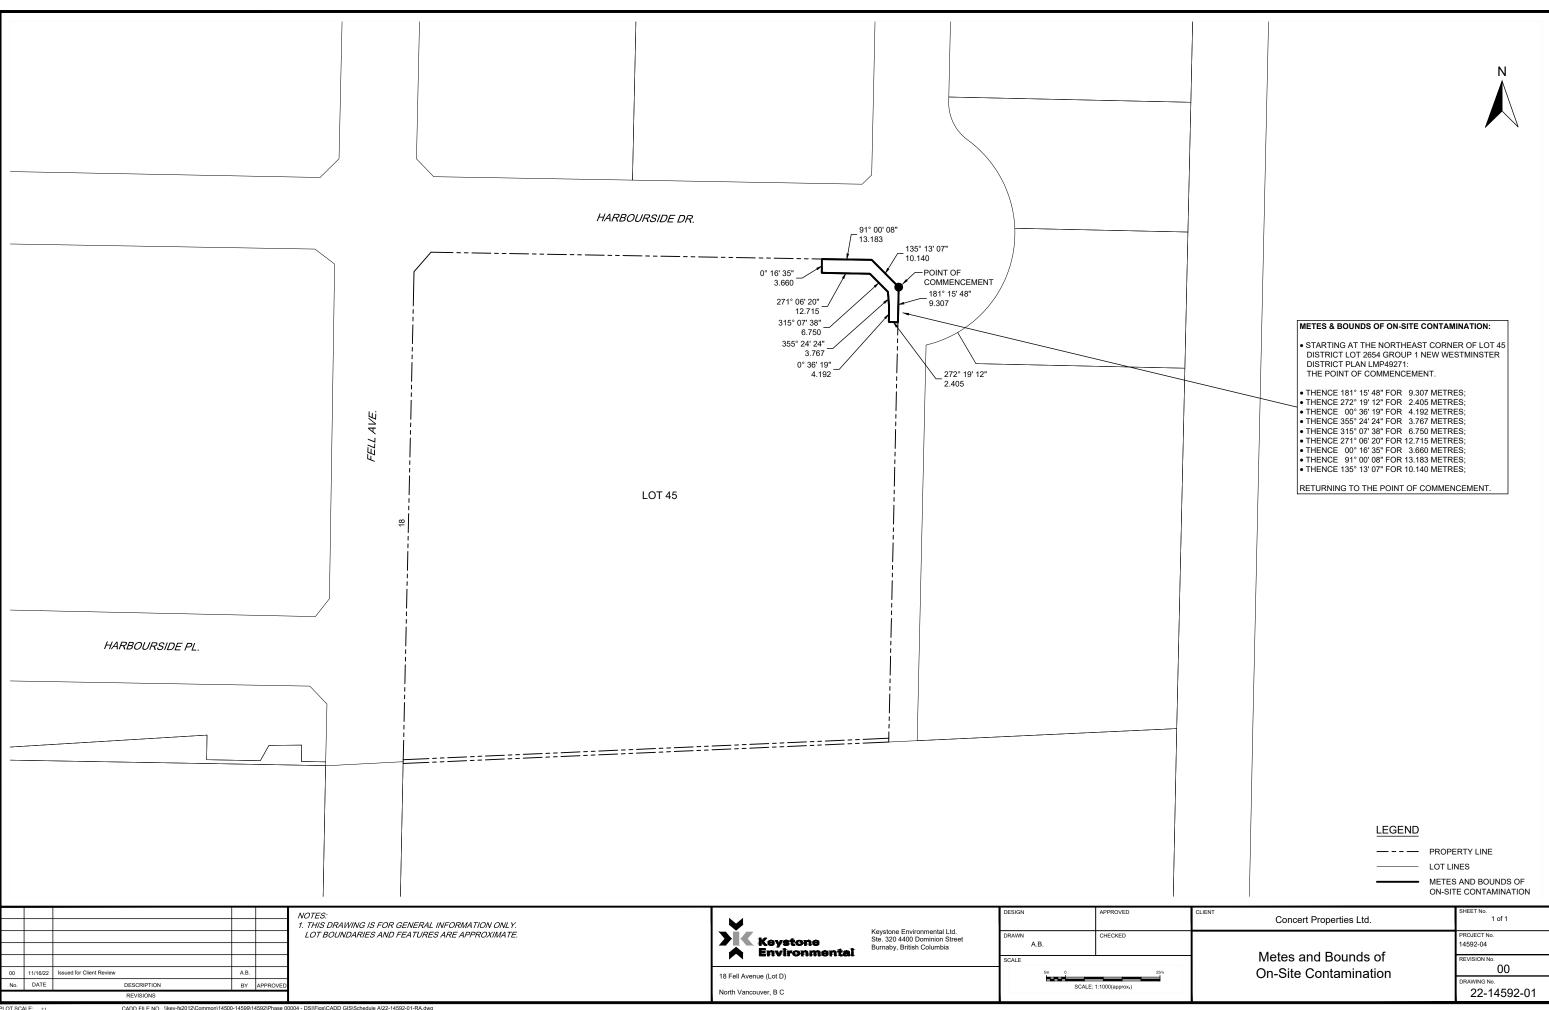
Contaminated soils located within the inferred areas of soil contamination, as shown and described by metes and bounds in Figure 22-14592-01, must remain covered by a minimum of 1.0 m of uncontaminated material or covered by intact pavement or building foundations.

- Mandatory notification provided to the Site owner/operator and workers involved in site redevelopment that contaminated soils located within the inferred areas of soil contamination, as shown and described by metes and bounds in **Figure 22-14592-01**, must remain covered by a minimum of 1.0 m of uncontaminated material or covered by intact pavement or building foundations.

Contaminated soils located within the inferred areas of soil contamination, as shown and described by metes and bounds in Figure 22-14592-01, must remain covered by a minimum of 1.0 m of uncontaminated material or covered by intact pavement or building foundations
