Re: Performance Verification Plan for Certificate of Compliance at the Mayfair Shopping Center, 3147 Douglas Street, Victoria, BC

Hemmera Envirochem Inc (Hemmera) has prepared this Performance Verification Plan (PVP) in support of an application for a Certificate of Compliance for the Mayfair Shopping Center property located at 3147 Douglas Street, Victoria, BC (the "Site"). The PVP presents the principle risk management measures that apply at the Site so that risk-based standards are and continue to be met and the actions that must be taken so that these risk controls are implemented and maintained. This PVP was prepared in accordance with BC Ministry of Environment (MOE) *Procedure 12: Procedures for Preparing and Issuing Contaminated Site Legal Instruments* dated January 14, 2014 (BC MOE 2014a) and BC MOE Administrative Guidance on Contaminated Sites: *Performance Verification Plans, Contingency Plans, and Operations and Maintenance Plans, Version 1.0* dated February 2014 (BC MOE 2014b).

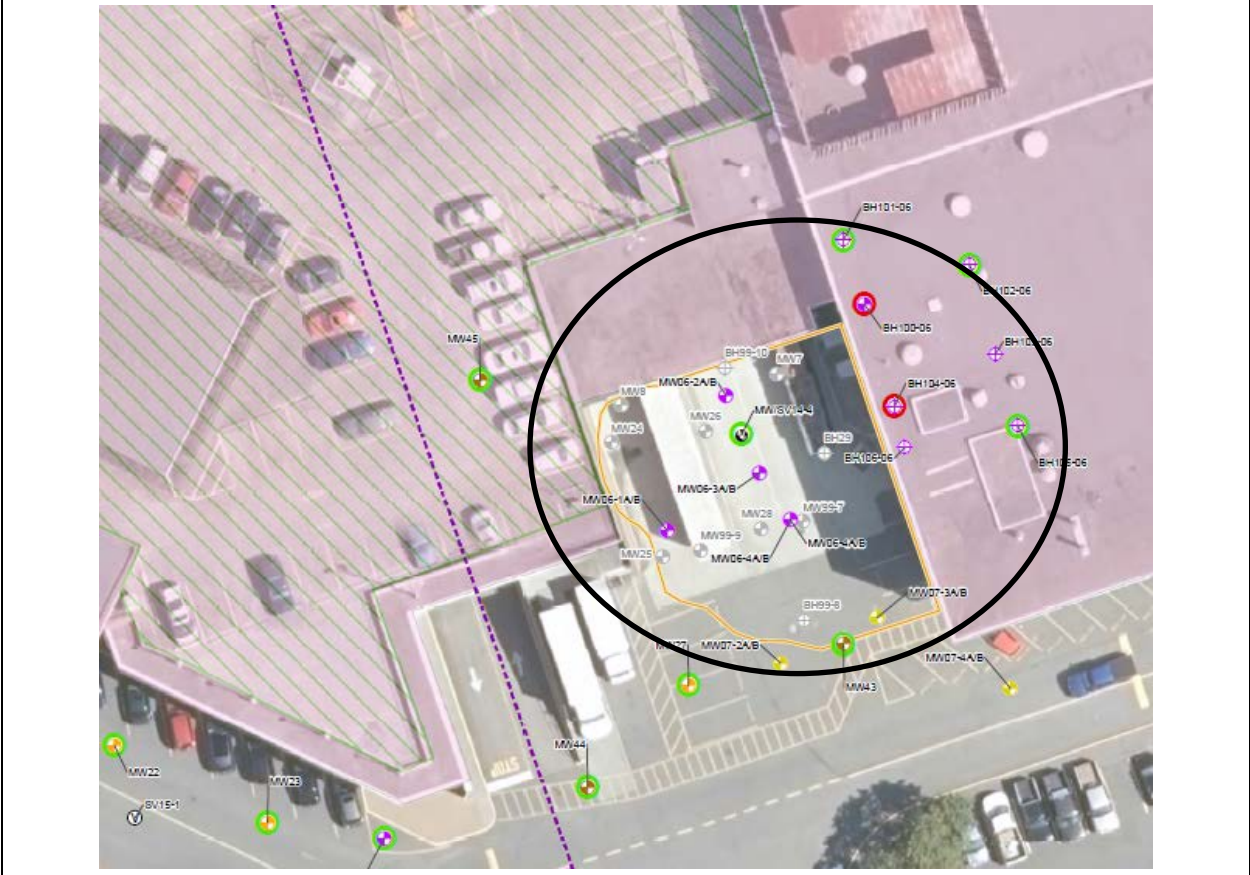
PVP CONDITION 1: CONCRETE

Condition	Concrete above petroleum-hydrocarbon impacted soil is still in place (location indicated below, circled in black).
Observation

- a) The petroleum hydrocarbon-impacted soil beneath the existing mall building must remain covered. Should the concrete above the impacted soil be removed in the future, exposed impacted soil must be excavated and disposed at an appropriate facility, or the concrete reinstated.
- b) Drinking water wells must not be installed on the Site.

Light and heavy extractable petroleum hydrocarbons (LEPH and HEPH, respectively) remain in soil at concentrations exceeding BC CSR Schedule 4 commercial land use standards. The SLRA concluded that the impacted soil beneath the mall building is unlikely to be exposed given that the current and proposed future Site use is a commercial shopping mall. Expansion or excavation in the vicinity of petroleum hydrocarbon-impacted soil is not planned or expected to occur due to the presence of shallow bedrock beneath the existing mall building. Although this condition would likely remain unchanged in the future, it is possible that the existing mall building could be demolished at some point in the future. Under this circumstance, exposed impacted soil should be excavated and disposed of at an appropriate facility or the concrete reinstated.
