Re: Performance Verification Plan for Certificate of Compliance for Lots 3 and 4, 4450 and 4451 Still Creek Drive & Portion of City of Burnaby Lands, Burnaby, BC (BC MOE Site Registry Numbers 314 and 1436)

PROJECT TITLE
**4450 & 4451 STILL CREEK DRIVE
 BURNABY, BC**

DRAWING TITLE
METES AND BOUNDS

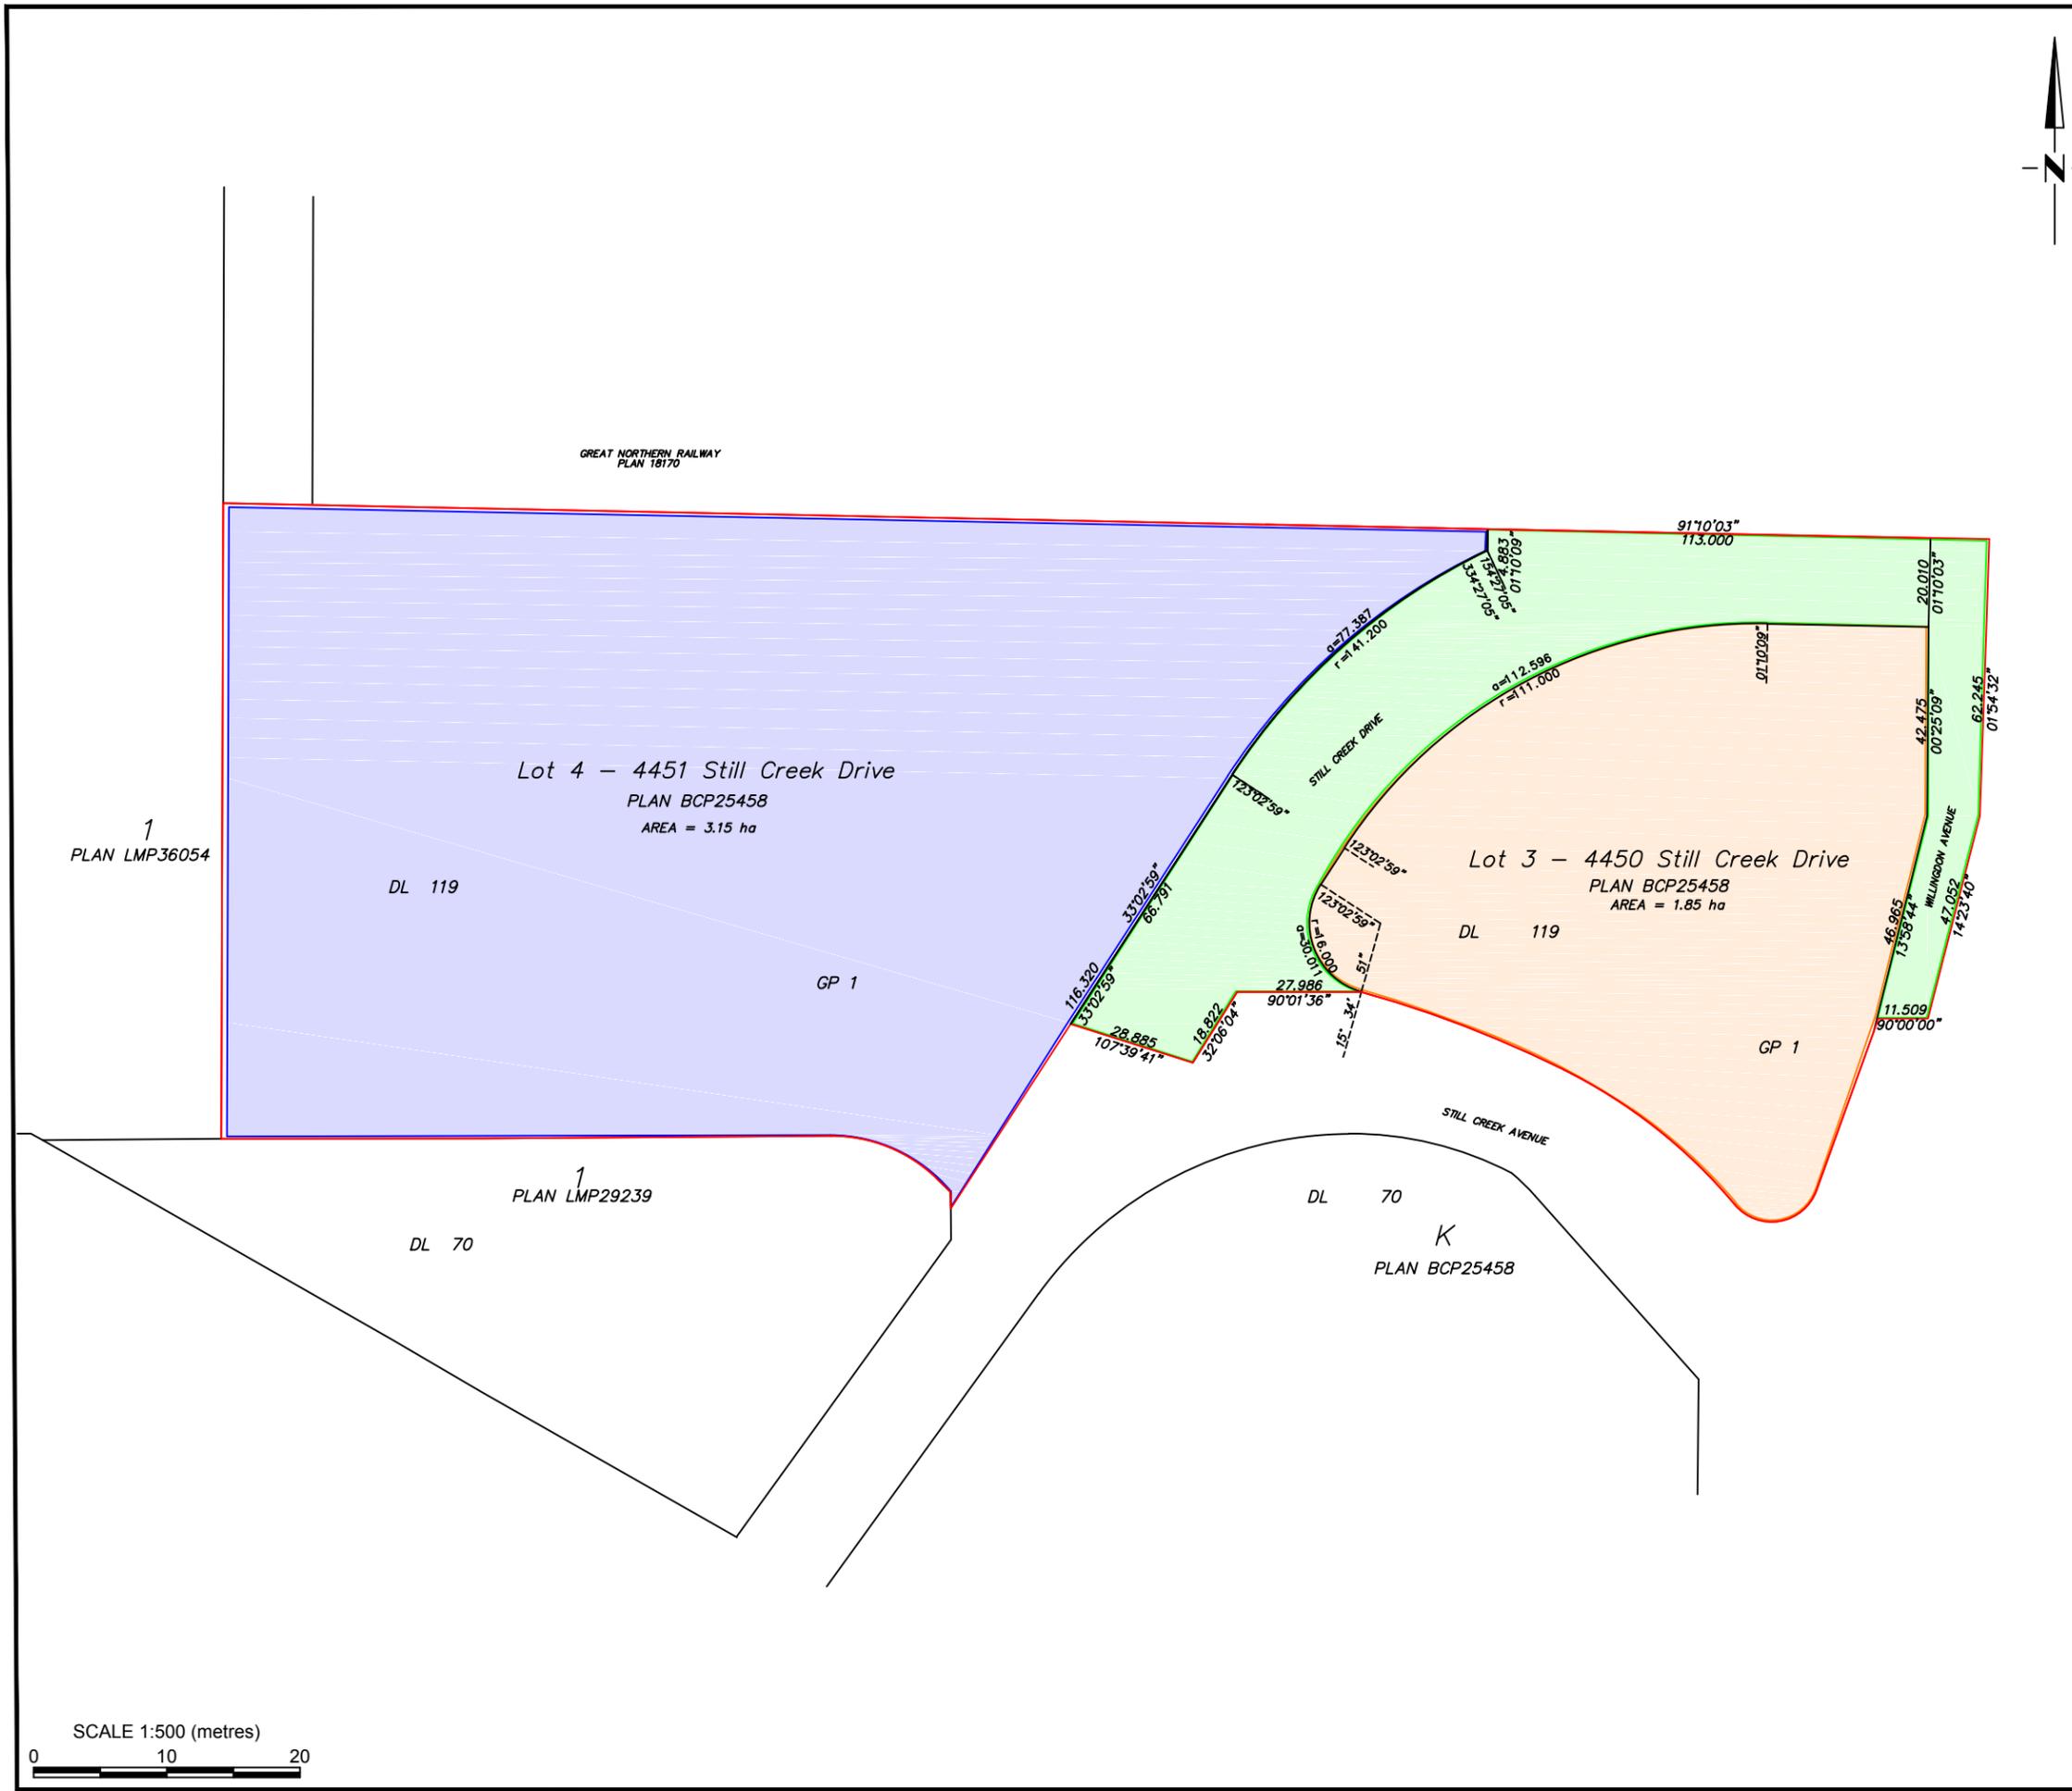
Figure 01 SHEET 1 of 1 REV 1

One CofC will be obtained for the following properties and respective owners:

- Still Creek Drive and a portion of land to the east of Lot 3
 [City of Burnaby]
 Legal Description: Metes and Bounds
- Lot 3 - 4450 Still Creek Drive
 [G & L Morrey Holdings Ltd.]
 Legal Description: Lot 3, District Lots 70 and 119, Group 1, New Westminster District Plan BCP25458
- Lot 4 - 4451 Still Creek Drive
 [4451 Still Creek Drive Investments Ltd]
 Legal Description: Lot 4, District Lots 70 and 119, Group 1, New Westminster District Plan BCP25458

Attch: Figure 1 Metes and Bounds
