Re: Performance Verification Plan for Certificate of Compliance 1168–1170 Derwent Way, Delta, BC Project No. 15063

Keystone Environmental Ltd. (Keystone Environmental) has prepared this Performance Verification Plan (PVP) in support of an application for a risk-based Certificate of Compliance (CofC) for the property referenced as 1168–1170 Derwent Way, Delta, BC (the "Site").

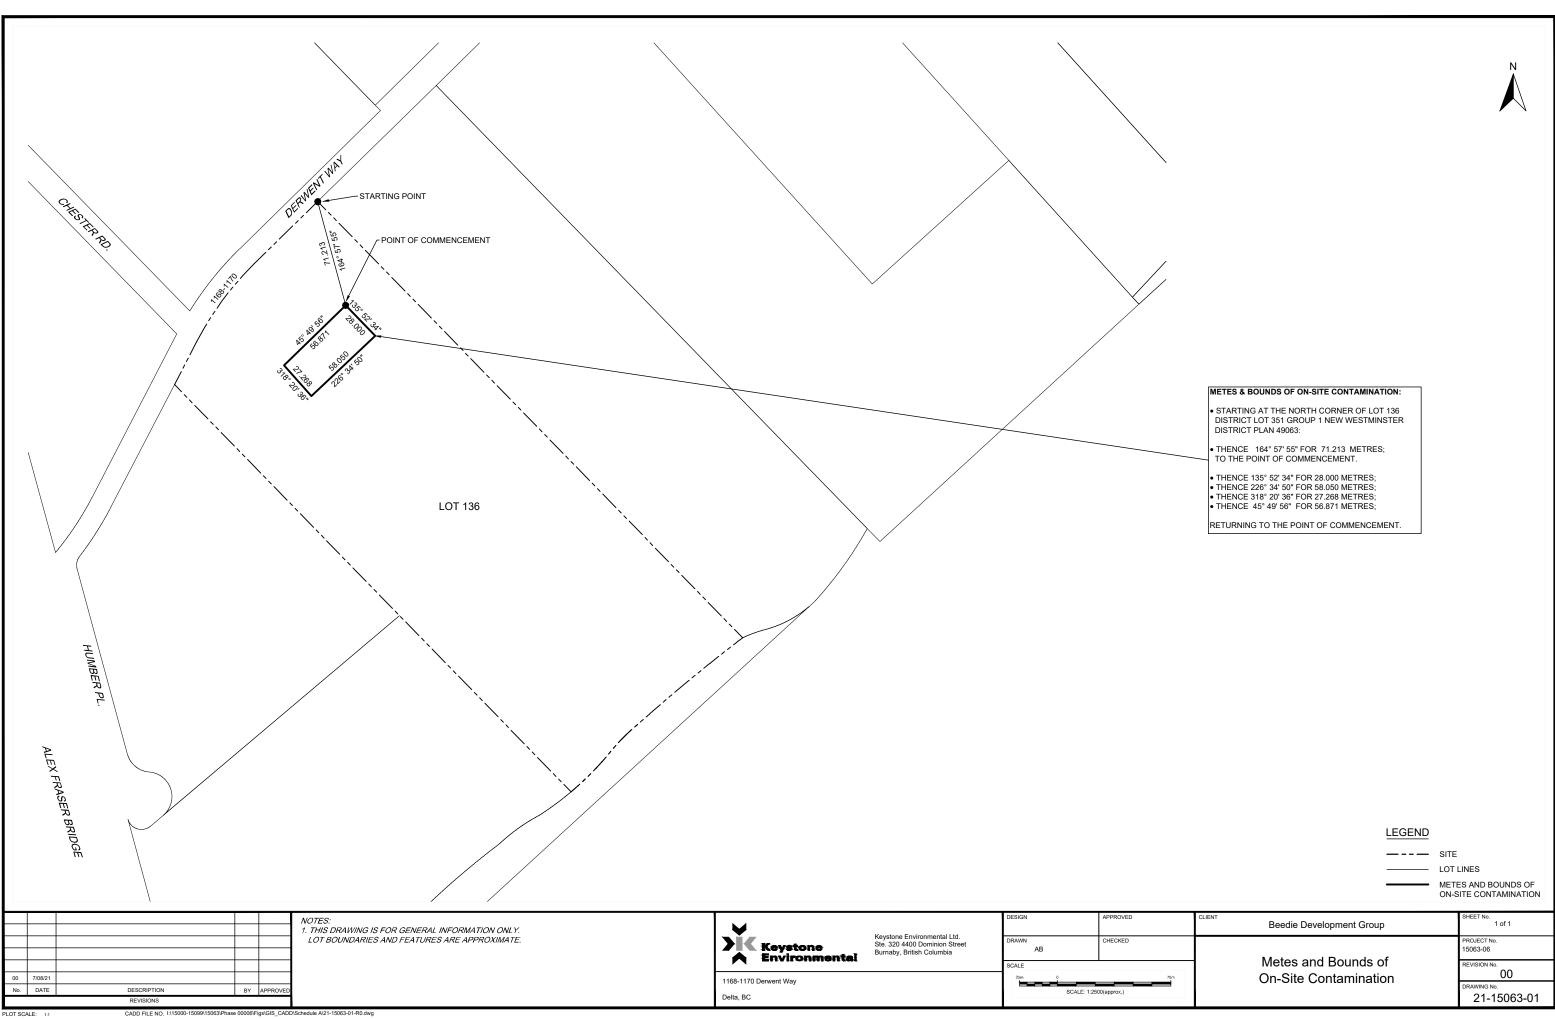
METES AND BOUNDS FIGURE

This risk controls were put in place to prevent exposure to soil and groundwater contamination by human and terrestrial ecological receptors at the Site. The metes and bounds description of the soil contamination to which the risk control related to the soil contamination applies is presented in **Figure 1**.

- Mandatory notification provided to the Site owner/operator by the responsible person that soil
 contamination must remain beneath impervious surfaces such as pavement or building
 foundations, or by at least 1.0 m of compliant soil material within the area of concern shown
 in the attached metes and bounds Figure 1.

- Mandatory notification provided to the Site owner/operator by the responsible person that if
 the soil contamination identified in Figure 1 is to be removed through excavation, a qualified
 environmental professional should be retained to characterize the material and advise on
 proper soil management and disposal.
